Report on
Geotechnical Investigation

Proposed Aged Care Facility
Lot 1 Haren Street, Mareeba

Prepared for
Croft Developments Pty Ltd

Project 90778.00
October 2018

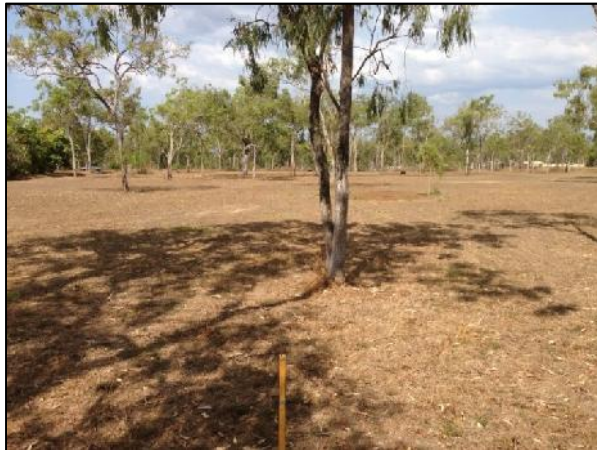
Figure 1: Looking east from near Pit 3

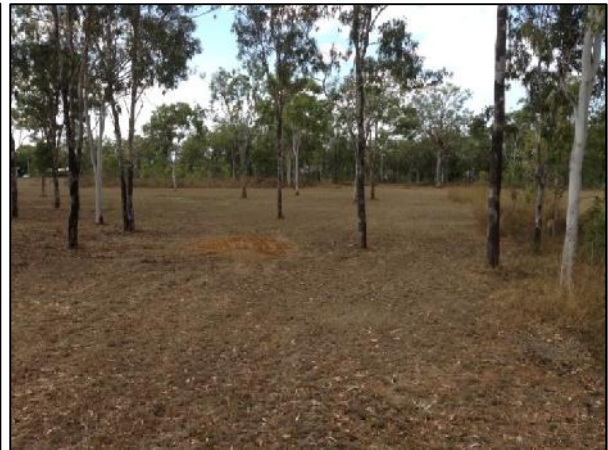
Figure 2: Looking north from near Pit 1

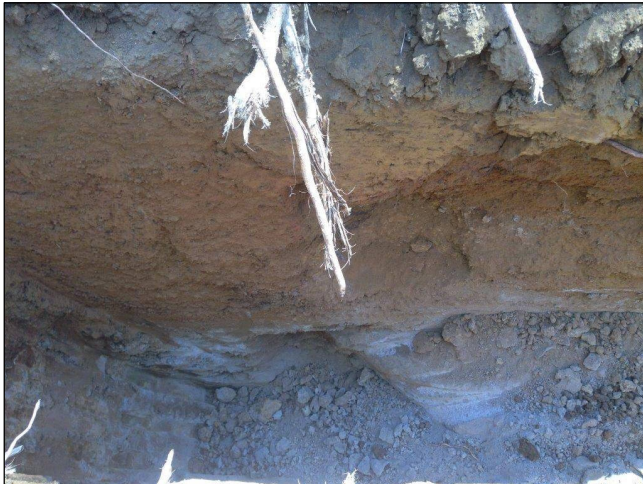
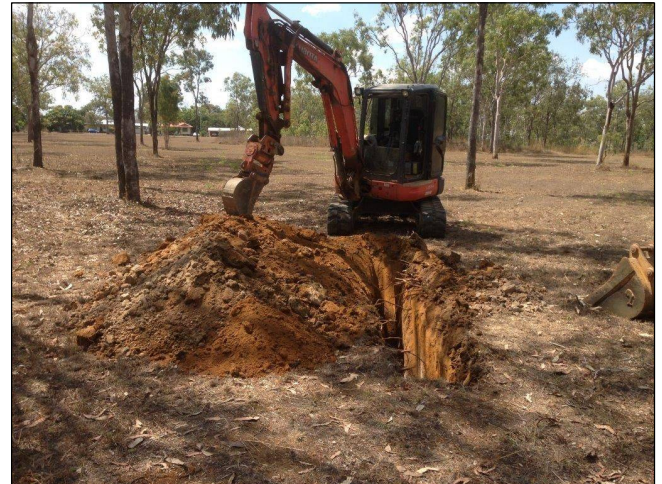
1.4	- estimated very high strength basalt (possibly large boulder) in middle of pit at approximately 1.25 m depth (moved pit to near end of trench)										
		BASALT - estimated very low to low strength light grey speckled black vesicular basalt		D	1.5

- generally low to medium strength below 1.5 m depth										
2	1.9	- zone of very stiff silty clay at far end of pit trench at 1.9 m depth										
		Pit discontinued at 1.9m depth - refusal

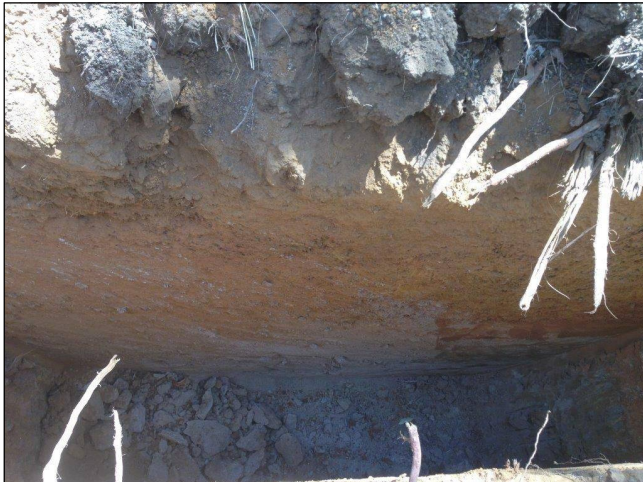
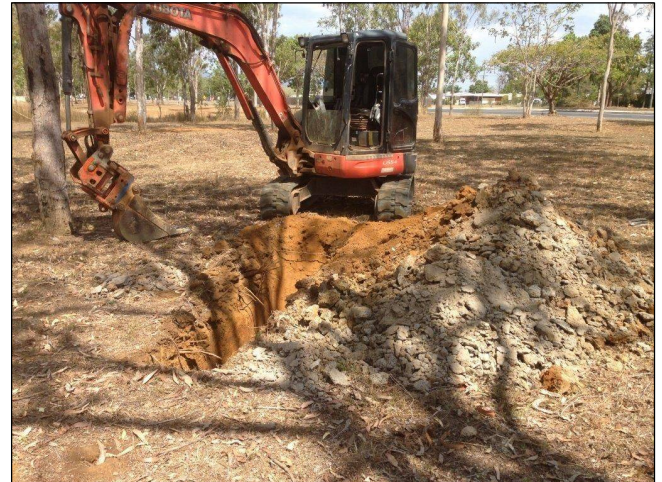
PIT No: 2
PROJECT No: 90778.00
DATE: 5/10/2018
SHEET 1 OF 1

RL	Depth (m)	Description of Strata	Graphic Log	Sampling & In Situ Testing				Water	Dynamic Penetrometer Test (blows per mm)			
				Type	Depth	Sample	Results & Comments		5	10	15	20
	0.1	TOPSOIL - grey silty clay topsoil with some rootlets; M<Wp										
		SILTY CLAY - hard orange brown silty clay, slightly gravelly. Gravel fine subrounded; M<Wp - tree root at 0.2 m depth			0.3		pp >600					
		- subrounded basalt boulder (0.5 m size) at 0.6 m depth			0.7		pp >600					
1	1.1	SILTY CLAY - very stiff to hard light grey silty clay; M<Wp. Vesicular basalt structure			1.0		pp >600	1				
					1.2		pp = 450					
	1.7	BASALT - estimated very low to low strength light grey vesicular basalt		D	1.8							
2	2.1	- estimated low to medium strength below 1.9 m depth - estimated medium strength at 2.1 m depth Pit discontinued at 2.1m depth - refusal		D	2.1

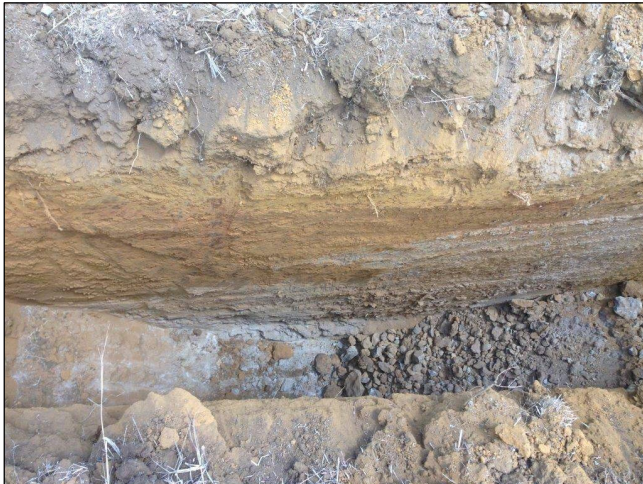
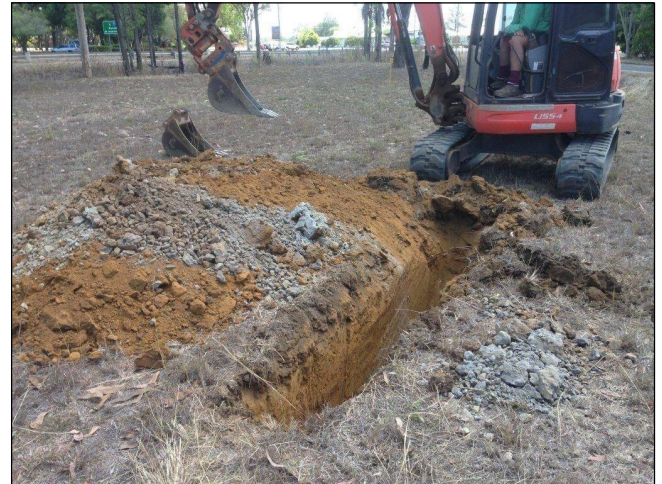
PIT No: 3
PROJECT No: 90778.00
DATE: 5/10/2018
SHEET 1 OF 1

RL	Depth (m)	Description of Strata	Graphic Log	Sampling & In Situ Testing				Water	Dynamic Penetrometer Test (blows per mm)			
				Type	Depth	Sample	Results & Comments		5	10	15	20
	0.05	TOPSOIL - grey silty clay with some rootlets; M<Wp										
		SILTY CLAY - hard orange brown silty clay, slightly gravelly (almost gravelly silty clay). Gravel fine subrounded; M>Wp		D	0.5		pp >600					
	1			D	1.0		pp >600					
	1.1	SILTY CLAY - very stiff grey brown silty clay; M<Wp		D	1.3		pp = 300-350					
	1.5	BASALT - estimated very low to low strength light grey speckled black vesicular basalt										
		- estimated low to medium strength below 1.7 m depth		D	1.8							
	1.9	- estimated medium strength at 1.9 m depth										
	2	Pit discontinued at 1.9m depth - refusal

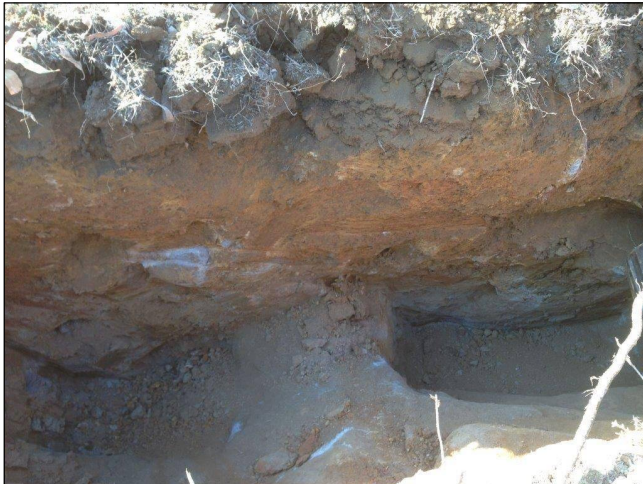
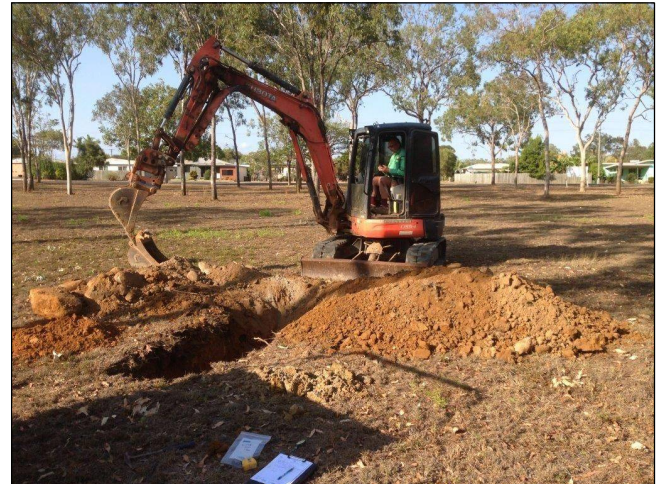
PIT No: 4
PROJECT No: 90778.00
DATE: 5/10/2018
SHEET 1 OF 1

RL	Depth (m)	Description of Strata	Graphic Log	Sampling & In Situ Testing				Water	Dynamic Penetrometer Test (blows per mm)			
				Type	Depth	Sample	Results & Comments		5	10	15	20
	0.1	TOPSOIL - grey silty clay with some rootlets; M<Wp										
		GRAVELLY SILTY CLAY - hard orange brown gravelly silty clay (almost silty clayey gravel) with numerous rounded to subrounded basalt boulders up to 0.8 m size. Gravel fine subangular; M<Wp		B	0.3 0.4		pp >600 (2 bags)					
				D	0.7		pp >600					
	1.1	- refusal at 1.0 m depth in middle of pit trench			1.05		pp >600					
		SILTY CLAY - very stiff light grey silty clay with numerous rounded to subrounded basalt boulders 0.3 m to 0.5 m size; M~Wp		D	1.3		pp = 300					
		- refusal at 1.5 m depth at far end of pit trench										
	1.7	Pit discontinued at 1.7m depth - refusal on probable boulders			1.7		pp = 300

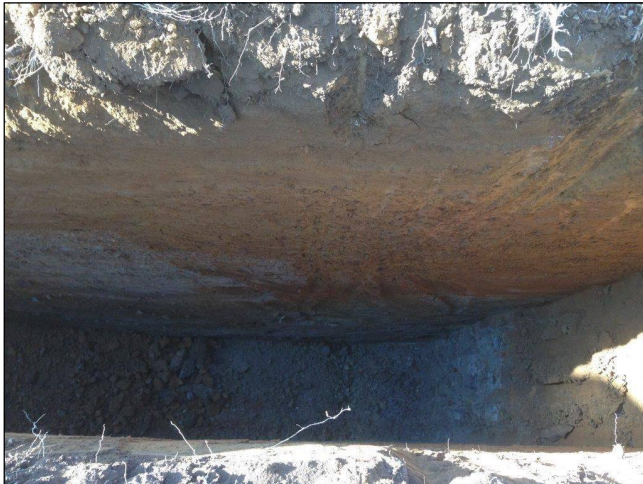
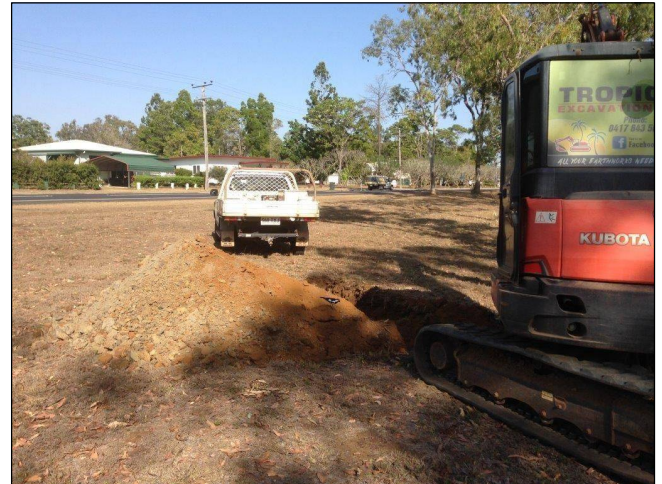
PIT No: 5
PROJECT No: 90778.00
DATE: 5/10/2018
SHEET 1 OF 1

RL	Depth (m)	Description of Strata	Graphic Log	Sampling & In Situ Testing				Water	Dynamic Penetrometer Test (blows per mm)			
				Type	Depth	Sample	Results & Comments		5	10	15	20
	0.1	TOPSOIL - dark grey silty clay topsoil with some rootlets; M<Wp										
		SILTY CLAY - hard orange brown silty clay, slightly gravelly; M<Wp		D	0.5		pp >600					
	1			D	1.0		pp >600	1				
	1.2	SILTY CLAY - hard light grey and brown silty clay; M<Wp		D	1.4		pp >600					
	2											
	2.0	BASALT - estimated very low strength grey speckled black vesicular basalt		D	2.1			2				
	2.5	- estimated very low to low strength below 2.4 m depth		D	2.5							
		Pit discontinued at 2.5m depth - refusal and limit of investigation

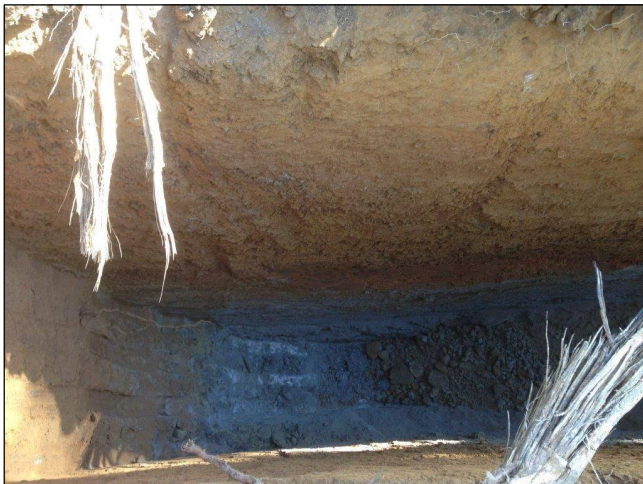
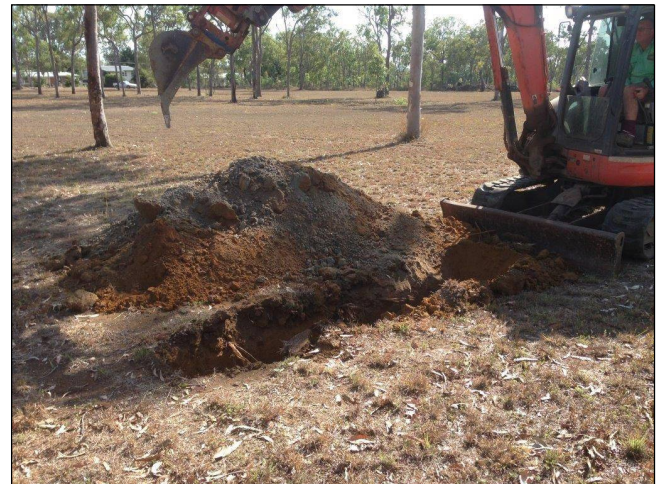
PIT No: 6
PROJECT No: 90778.00
DATE: 5/10/2018
SHEET 1 OF 1

RL	Depth (m)	Description of Strata	Graphic Log	Sampling & In Situ Testing				Water	Dynamic Penetrometer Test (blows per mm)			
				Type	Depth	Sample	Results & Comments		5	10	15	20
	0.1	TOPSOIL - dark grey silty clay topsoil with some rootlets; M<Wp										
		SILTY CLAY - hard orange brown silty clay, slightly gravelly (almost gravelly silty clay). Gravel fine and subrounded; M<Wp		B	0.6		(2 bags)					
1												
	1.2	SILTY CLAY - very stiff light grey and brown silty clay; M<Wp		D	1.4							
	1.8	BASALT - estimated very low strength grey speckled black vesicular basalt - estimated low strength below 2.0 m depth										
2												
	2.3	- estimated medium to high strength at 2.3 m depth Pit discontinued at 2.3m depth - refusal		D	2.3

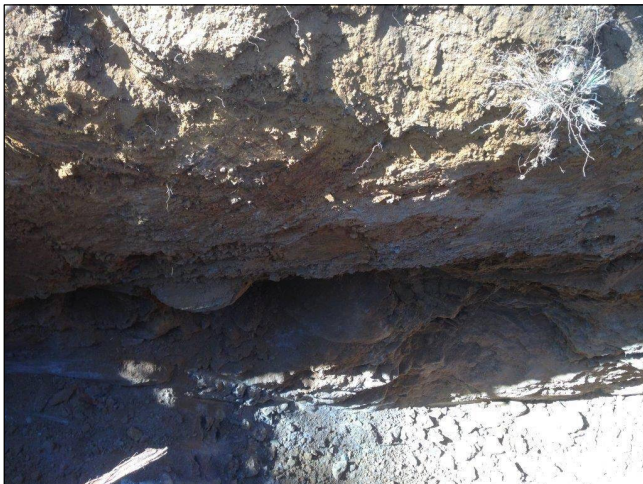
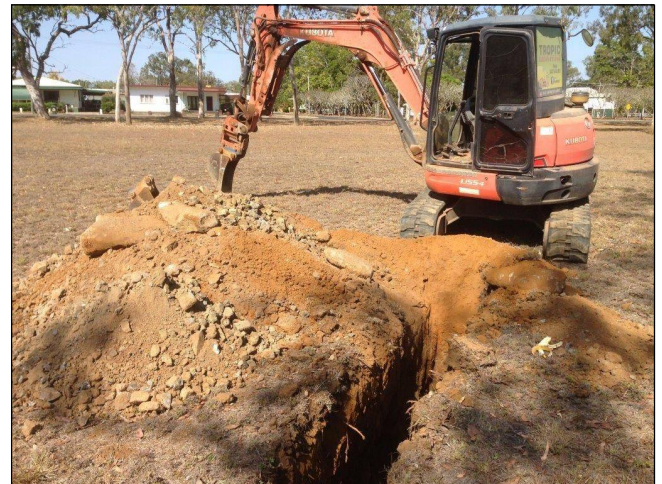
PIT No: 7
PROJECT No: 90778.00
DATE: 5/10/2018
SHEET 1 OF 1

RL	Depth (m)	Description of Strata	Graphic Log	Sampling & In Situ Testing				Water	Dynamic Penetrometer Test (blows per mm)			
				Type	Depth	Sample	Results & Comments		5	10	15	20
	0.1	TOPSOIL - grey silty clay topsoil with some rootlets; M<Wp										
		SILTY CLAY - hard orange brown silty clay, slightly gravelly with some rounded to subrounded basalt boulders up to 0.4 m size. Gravel fine and subrounded; M<Wp			0.5		pp >600					
1	1.1	BOULDERS and SILTY CLAY - estimated very high strength rounded to subrounded basalt boulders (up to 0.8m size) in a very stiff to hard light grey and grey silty clay matrix						1				
	1.7	BASALT - estimated low strength grey speckled black vesicular basalt		D	1.6		pp = 400					
2	2.0	- estimated low to medium strength at approximately 2.0 m depth Pit discontinued at 2.0m depth - refusal		D	2.0			2

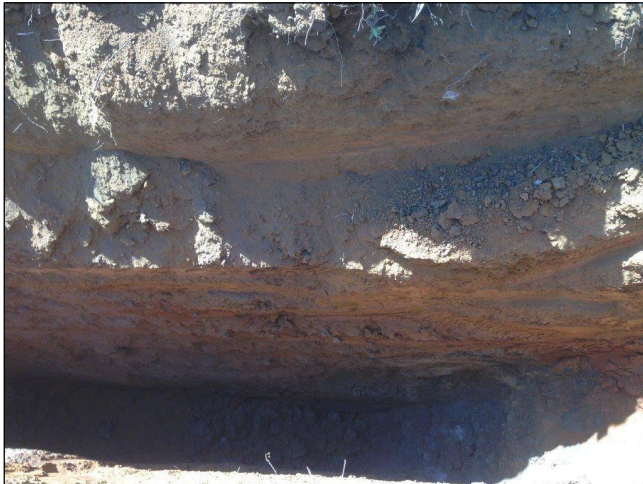
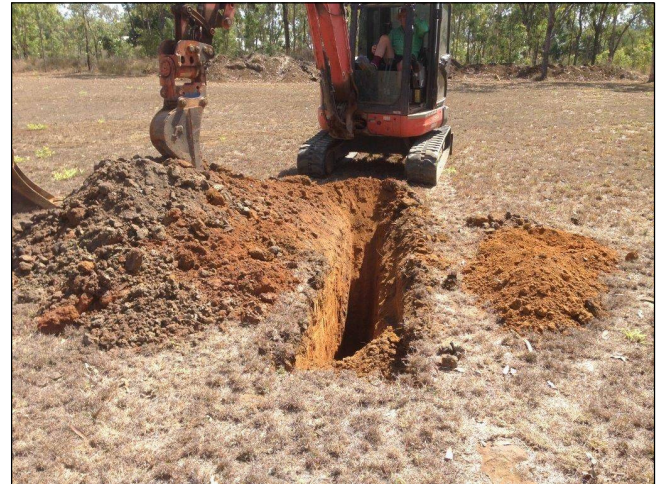
- red brown mottled grey below 0.7 m depth		D	0.8		pp >600					
1	1.1	SILTY CLAY - very stiff light grey silty clay, with some zones of dark grey estimated very low strength vesicular basalt; M<Wp		D	1.4		pp = 350	1				
2	1.8	BASALT - estimated very low to low strength light grey speckled black vesicular basalt						2

- estimated low to medium strength below 2.2 m depth										
	2.5	Pit discontinued at 2.5m depth - limit of investigation		D	2.5

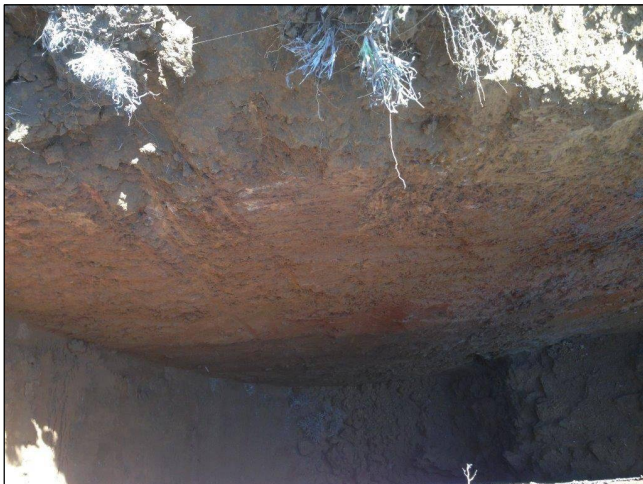
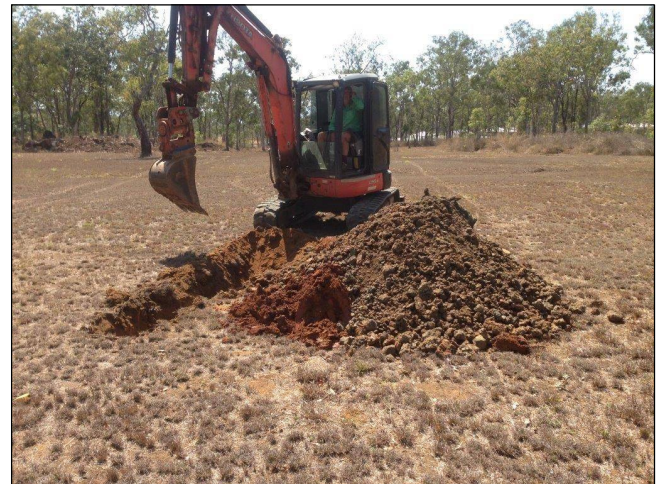
PIT No: 9
PROJECT No: 90778.00
DATE: 5/10/2018
SHEET 1 OF 1

RL	Depth (m)	Description of Strata	Graphic Log	Sampling & In Situ Testing				Water	Dynamic Penetrometer Test (blows per mm)			
				Type	Depth	Sample	Results & Comments		5	10	15	20
	0.1	TOPSOIL - grey brown silty clay with some topsoil; M<Wp										
		GRAVELLY SILTY CLAY - hard orange brown gravelly silty clay (almost silty clayey gravel). Gravel fine to medium and subrounded; M<Wp			0.4		pp >600					
				D	0.8		pp >600					
				D	1.0		pp >600	1				
	1.2	SILTY CLAY - hard grey mottled red brown silty clay; M<Wp		D	1.3		pp >600					
		- very stiff and light grey below 1.5 m depth with some gravel to cobble sized remaining zones of estimated very low strength dark grey vesicular basalt			1.6		pp = 300					
				D	2.3		pp = 350	2				
	2.6	Pit discontinued at 2.6m depth - limit of investigation

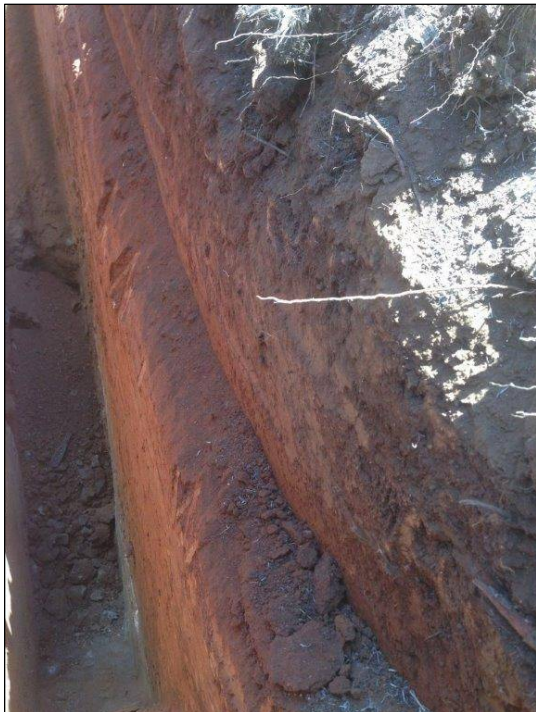
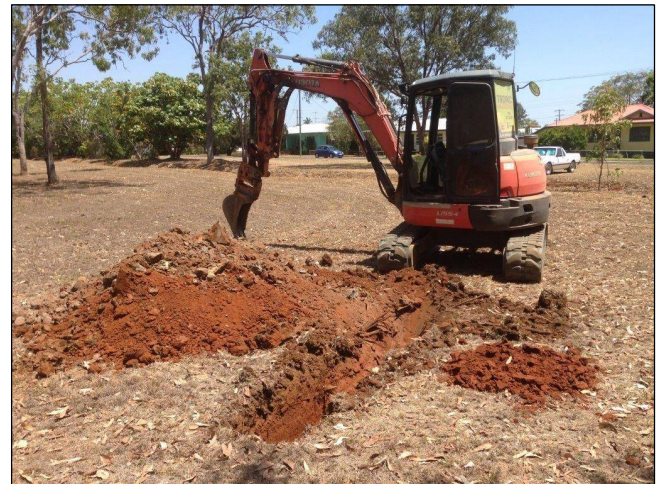
PIT No: 10
PROJECT No: 90778.00
DATE: 5/10/2018
SHEET 1 OF 1

RL	Depth (m)	Description of Strata	Graphic Log	Sampling & In Situ Testing				Water	Dynamic Penetrometer Test (blows per mm)			
				Type	Depth	Sample	Results & Comments		5	10	15	20
	0.2	TOPSOIL - grey silty clay with some rootlets; M<Wp										
		SILTY CLAY - hard red brown silty clay with some fine subrounded gravel; M<Wp - tree root at 0.2 m depth		B	0.4		pp >600 (2 bags)					
					0.7		pp >600					
		- orange brown below 0.8 m depth		D	1.0		pp >600	1				
	1.3	SILTY CLAY - very stiff grey and grey brown silty clay; M<Wp - rounded to subrounded basalt boulders in near end of pit at 1.4 m depth		D	1.5		pp = 350					
	2.0	BASALT - estimated very low to low strength dark grey vesicular basalt		D	2.3			2				
	2.5	Pit discontinued at 2.5m depth - limit of investigation

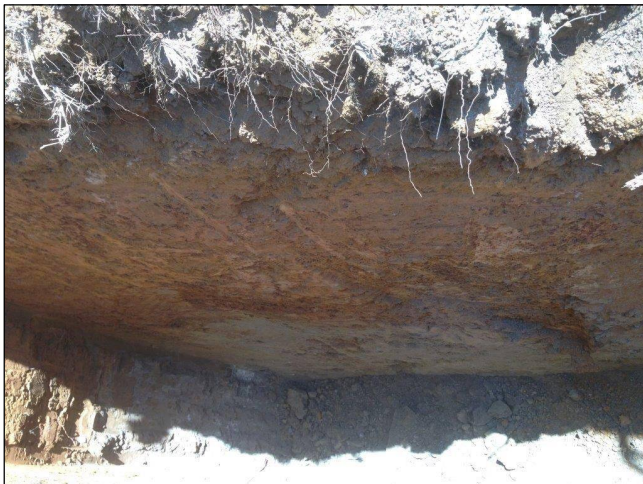
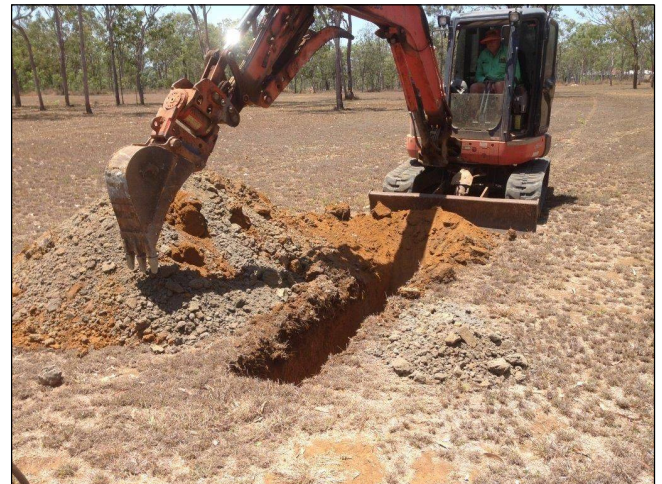
PIT No: 11
PROJECT No: 90778.00
DATE: 5/10/2018
SHEET 1 OF 1

RL	Depth (m)	Description of Strata	Graphic Log	Sampling & In Situ Testing				Water	Dynamic Penetrometer Test (blows per mm)			
				Type	Depth	Sample	Results & Comments		5	10	15	20
	0.2	TOPSOIL - grey silty clay with some rootlets; M<Wp										
		SILTY CLAY - hard orange brown silty clay, slightly gravelly. Gravel fine and subrounded; M<Wp		D	0.5		pp >600					
		- light orange brown with some gravel below 0.7 m depth										
	1			D	1.0		pp >600	1				
	1.2	SILTY CLAY - very stiff light grey and grey brown silty clay; M<Wp		D	1.5		pp = 300					
	1.9	BASALT - estimated very low strength grey speckled black vesicular basalt		D	2.0			2				
		- estimated low to medium strength below 2.4 m depth										
	2.6	Pit discontinued at 2.6m depth - refusal and limit of investigation		D	2.6

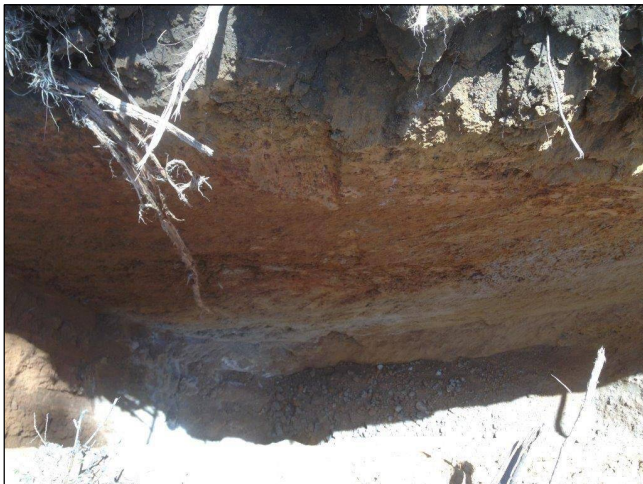
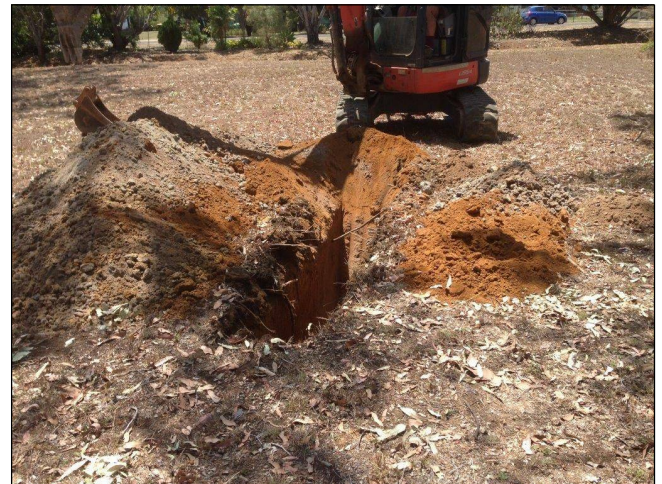
PIT No: 12
PROJECT No: 90778.00
DATE: 5/10/2018
SHEET 1 OF 1

RL	Depth (m)	Description of Strata	Graphic Log	Sampling & In Situ Testing				Water	Dynamic Penetrometer Test (blows per mm)			
				Type	Depth	Sample	Results & Comments		5	10	15	20
	0.2	TOPSOIL - grey silty clay topsoil with some rootlets; M<Wp										
		SILTY CLAY - hard orange brown silty clay, slightly gravelly. Gravel fine and subrounded; M<Wp		B	0.5		pp >600 (2 bags)					
1				D	1.0		pp >600	1				
	1.4	SILTY CLAY - very stiff grey and grey brown silty clay; M<Wp		D	1.5							
	1.7	BASALT - estimated very low to low strength light grey speckled black vesicular basalt										
2		- estimated low to medium strength below 2.0 m depth		D	2.0			2				
	2.3	- estimated medium strength at 2.3 m depth Pit discontinued at 2.3m depth - refusal		D	2.3

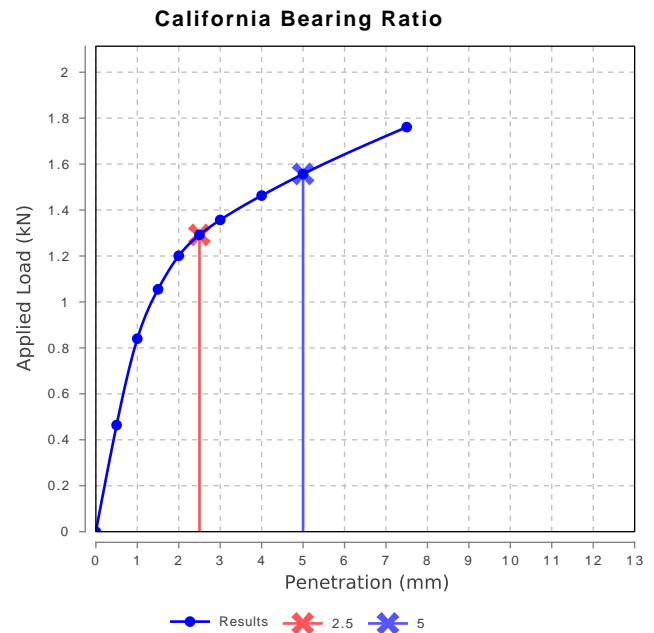
California Bearing Ratio (AS 1289 6.1.1 & 2.1.1)		Min	Max
CBR taken at	2.5 mm		
CBR %	10		
Method of Compactive Effort	Standard		
Method used to Determine MDD	AS 1289 5.1.1 & 2.1.1		
Method used to Determine Plasticity	AS1289 3.1.2		
Maximum Dry Density (t/m ³)	1.69		
Optimum Moisture Content (%)	21.5		
Laboratory Density Ratio (%)	99.5		
Laboratory Moisture Ratio (%)	99.5		
Dry Density after Soaking (t/m ³)	1.68		
Field Moisture Content (%)	18.8		
Moisture Content at Placement (%)	21.4		
Moisture Content Top 30mm (%)	26.2		
Moisture Content Rest of Sample (%)	24.0		
Mass Surcharge (kg)	4.5		
Soaking Period (days)	4		
Curing Hours	132		
Swell (%)	0.5		
Oversize Material (mm)	19		
Oversize Material Included	0.0		
Oversize Material (%)	0
